Value by Design: Smart Design Principles for Neighborhood Shopping Centers

Chanam Lee*, Atef Sharkawy**, and Shan Gao***

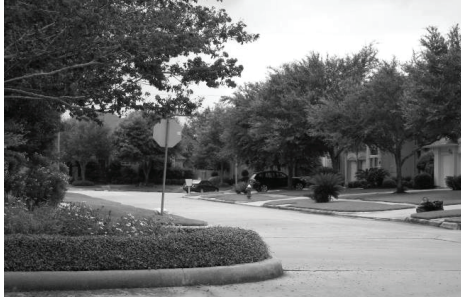
Adjacent Neighborhood, Single Family with Landscaping

Figure 4.
Visual Quality of the Shopping Center and the Surrounding Neighborhoods.

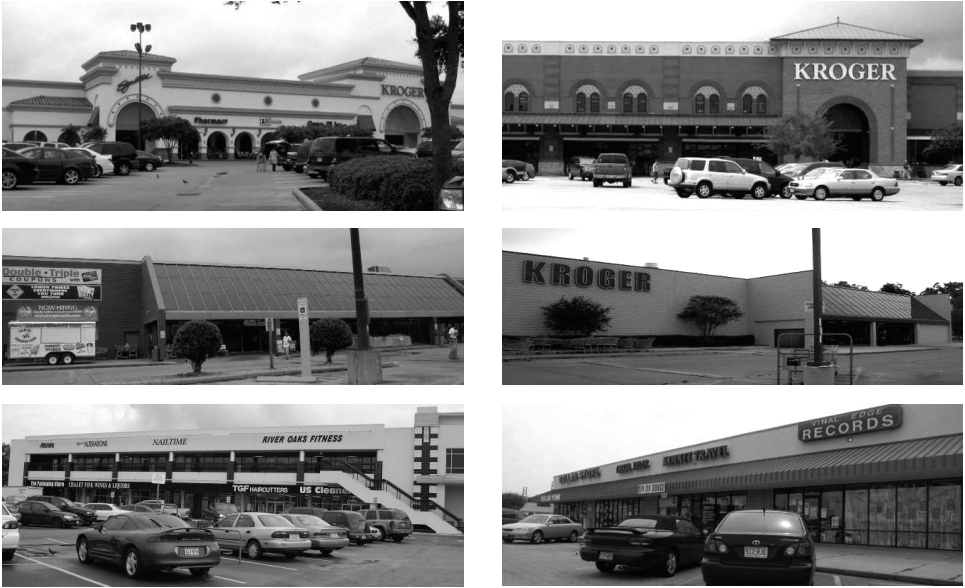
Figure 5.
Variations in Architectural Designs.

Some variations in architectural styles were found, especially those located in central areas. Those shopping centers in suburban areas appeared to have similar building designs. Architectural variations seemed to be focused on the entrance area including the rooflines, openings, colors, materials, and modulated surfaces. Two of the newer developments (Stores No. 46 and No. 35) incorporated design features that appeared to be included to appeal to pedestrians and to enrich the overall shopping experience, including walkways, awnings, extended seating areas near entrance, and window displays. The shopping centers with the more appealing design attributes and better accessibility from the adjacent neighborhoods tended to be located in more central areas, higher income areas, and/or areas with more White shoppers. Stores located in poorer neighborhoods or in areas with large numbers of minority shoppers had significantly poorer overall design quality and poorer maintenance conditions. They also often had trash, cracks, and peeling paint in their parking lots, and overgrown weeds and trash on nearby streets and sidewalks.
